# Manhole Inspection Summary

Manhole # S57K\_\_006MH

Insp Date: **5/15/08 12:07 PM**

**Location** Address: **foster ave**

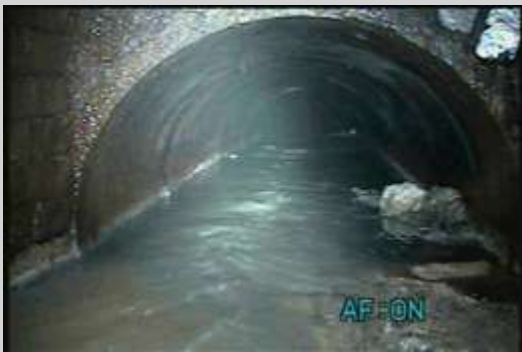
12 O'Clock Outflow

27 in. Circular Gravity Sewer  
Pipe Out @ 12 O'Clock

Pipe Material: **Clay** ☐ Pipe Lined

Invert Depth: **24.20** (ft.) Flow Characteristics: **Fast**

Deposits: ☒ None ☐ Mud ☐ Sludge ☐ Debris ☐ Grease

Infiltration: **None** Pipe Seal Cond: **Unknown**

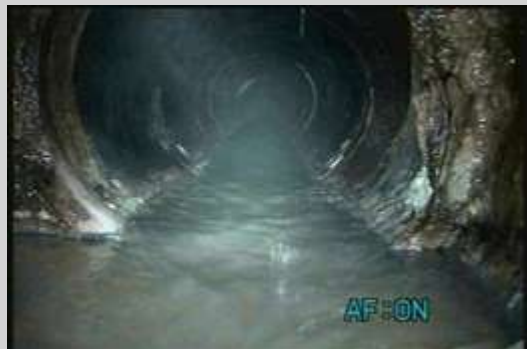
6 O'Clock Inflow

24 in. Circular Gravity Sewer  
Pipe In @ 6 O'Clock

Pipe Material: **Clay** ☐ Pipe Lined

Infiltration: **None** Pipe Seal Cond: **Unknown**
